MTL TR 87-44

# **EVALUATION OF** THIXOCAST CARTRIDGE **STOP PAWLS**

PERRY R. SMOOT

September 1987

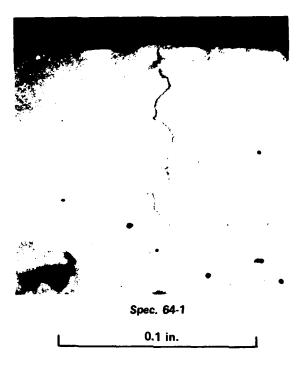
Figure 10. Surface cooling crack through prior liquid and around primary solid.

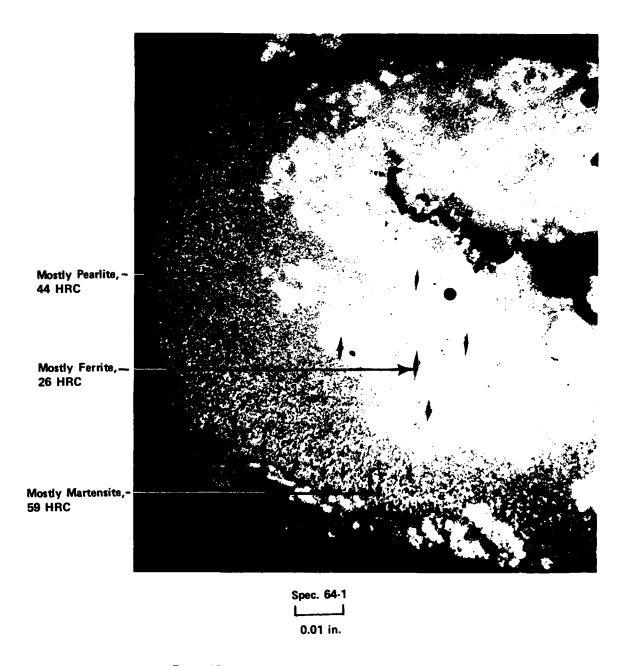
Figure 11b. Three phase inclusion.
